Location Restrictions

Nelsen Pond

Otter Tail Power Company- Coyote Station

This report presents documentation and certification for the location standards for the Nelsen Pond at Coyote Station in Beulah, North Dakota. Nelsen Pond is an “existing” (i.e. received coal combustion residuals both before and after October 14, 2015) coal combustion residual (CCR) surface impoundment.

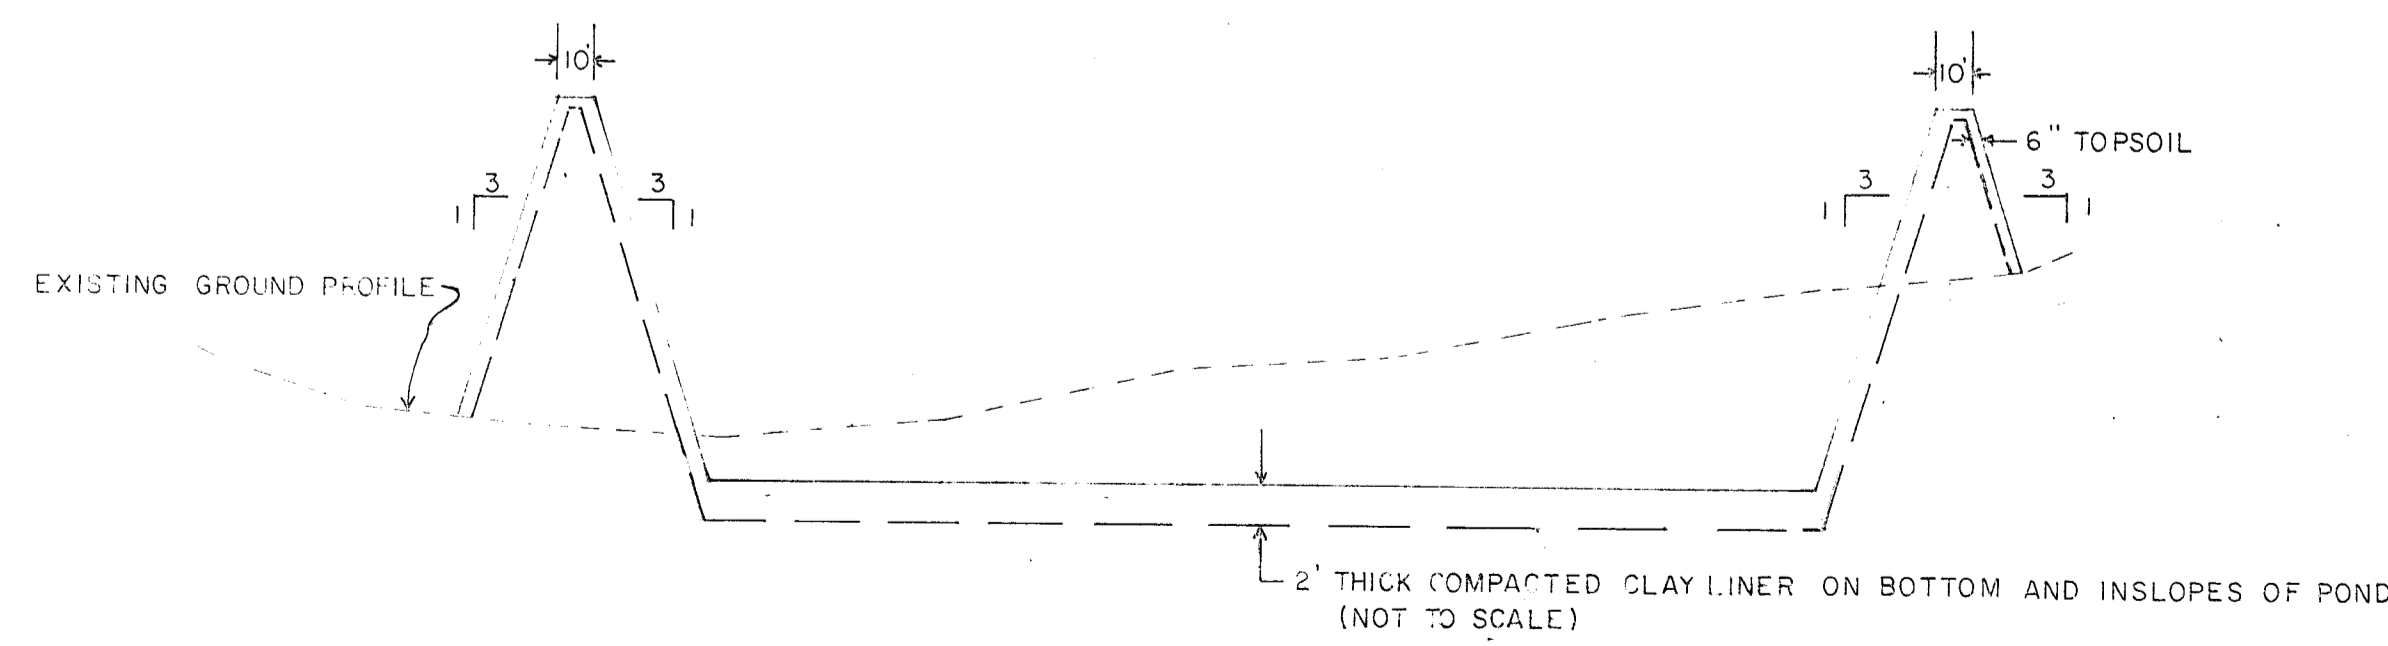
CCR LOCATION DOCUMENTATION REPORT
 NELSEN POND
 FIGURE 1
 BASE LINER CONTOURS

SECTION A-A
 HORIZ. SCALE 1" = 50'
 VERT. SCALE 1" = 5'

NOTE: Add 816 feet to provided contours to convert elevations
 1935 Elevation adjusted to current datum

Figure 1 shows the base liner contours of Nelsen Pond, and Figure 2 shows the groundwater contours from August 2016.

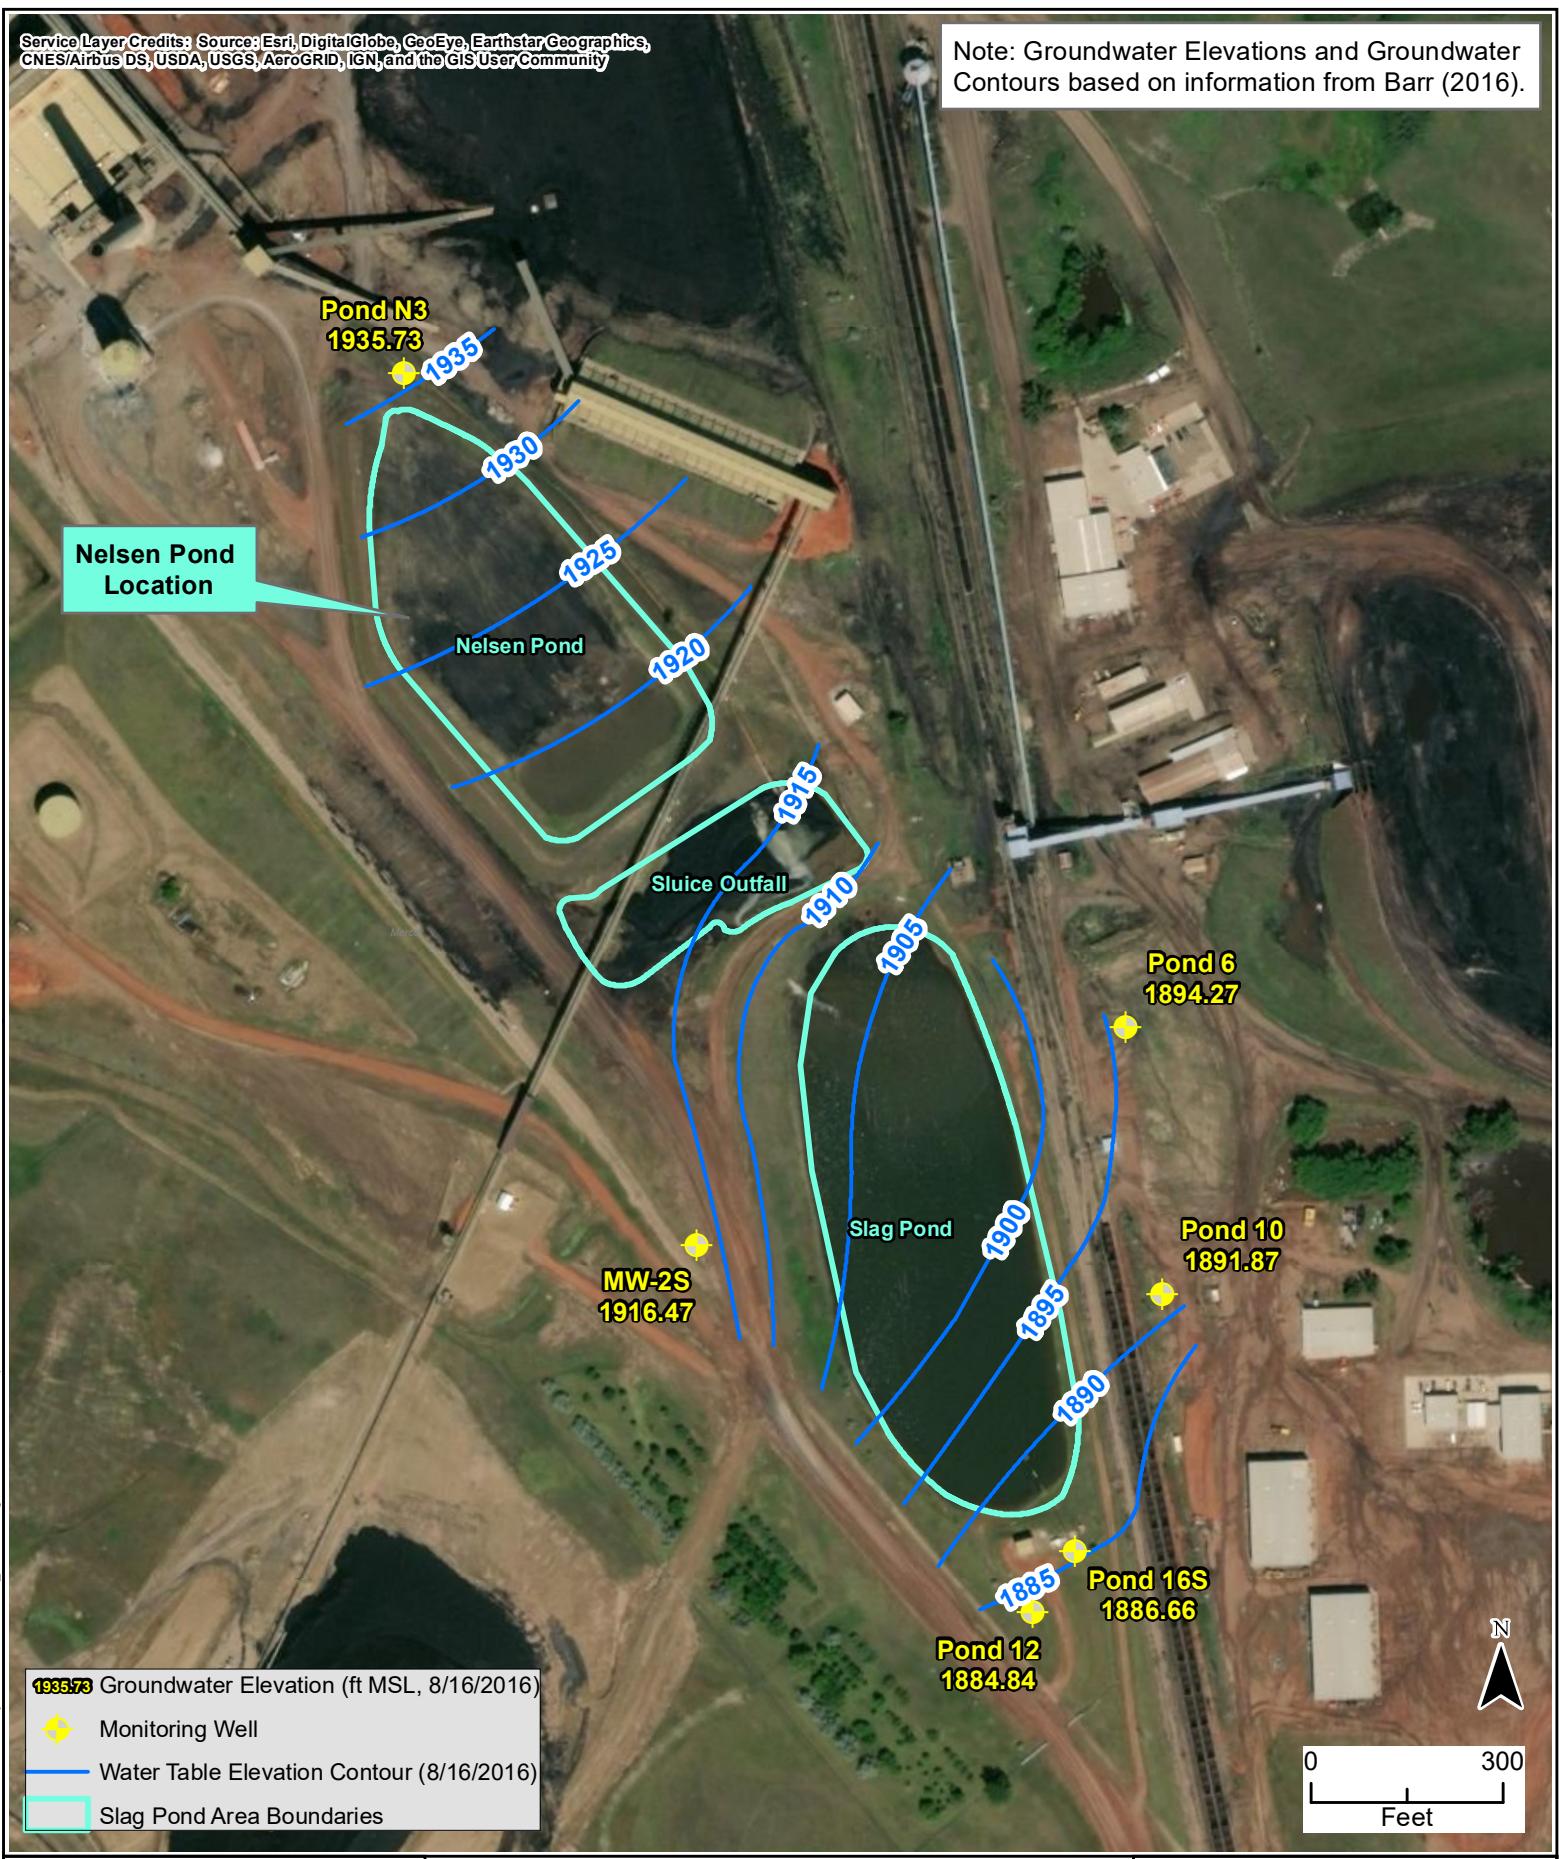
Note: Groundwater Elevations and Groundwater Contours based on information from Barr (2016).

1935.73 Groundwater Elevation (ft MSL, 8/16/2016)

Water Table Elevation Contour (8/16/2016)

Based on groundwater elevation measurements reported in the *Groundwater Monitoring System Report – Slag Pond Area (Barr, 2016)*, the minimum separation from the base of Nelsen Pond to the groundwater table during August 2016 was 7.5 feet. This occurred in the northern end of Nelsen Pond.
