## Initial Safety Factor Assessment

### Nelsen Pond

Otter Tail Power Company – Coyote Station

This report presents the initial safety factor assessment and certification of the Nelsen Pond at Coyote Station in Beulah, North Dakota. The Nelsen Pond is an “existing” surface impoundment.

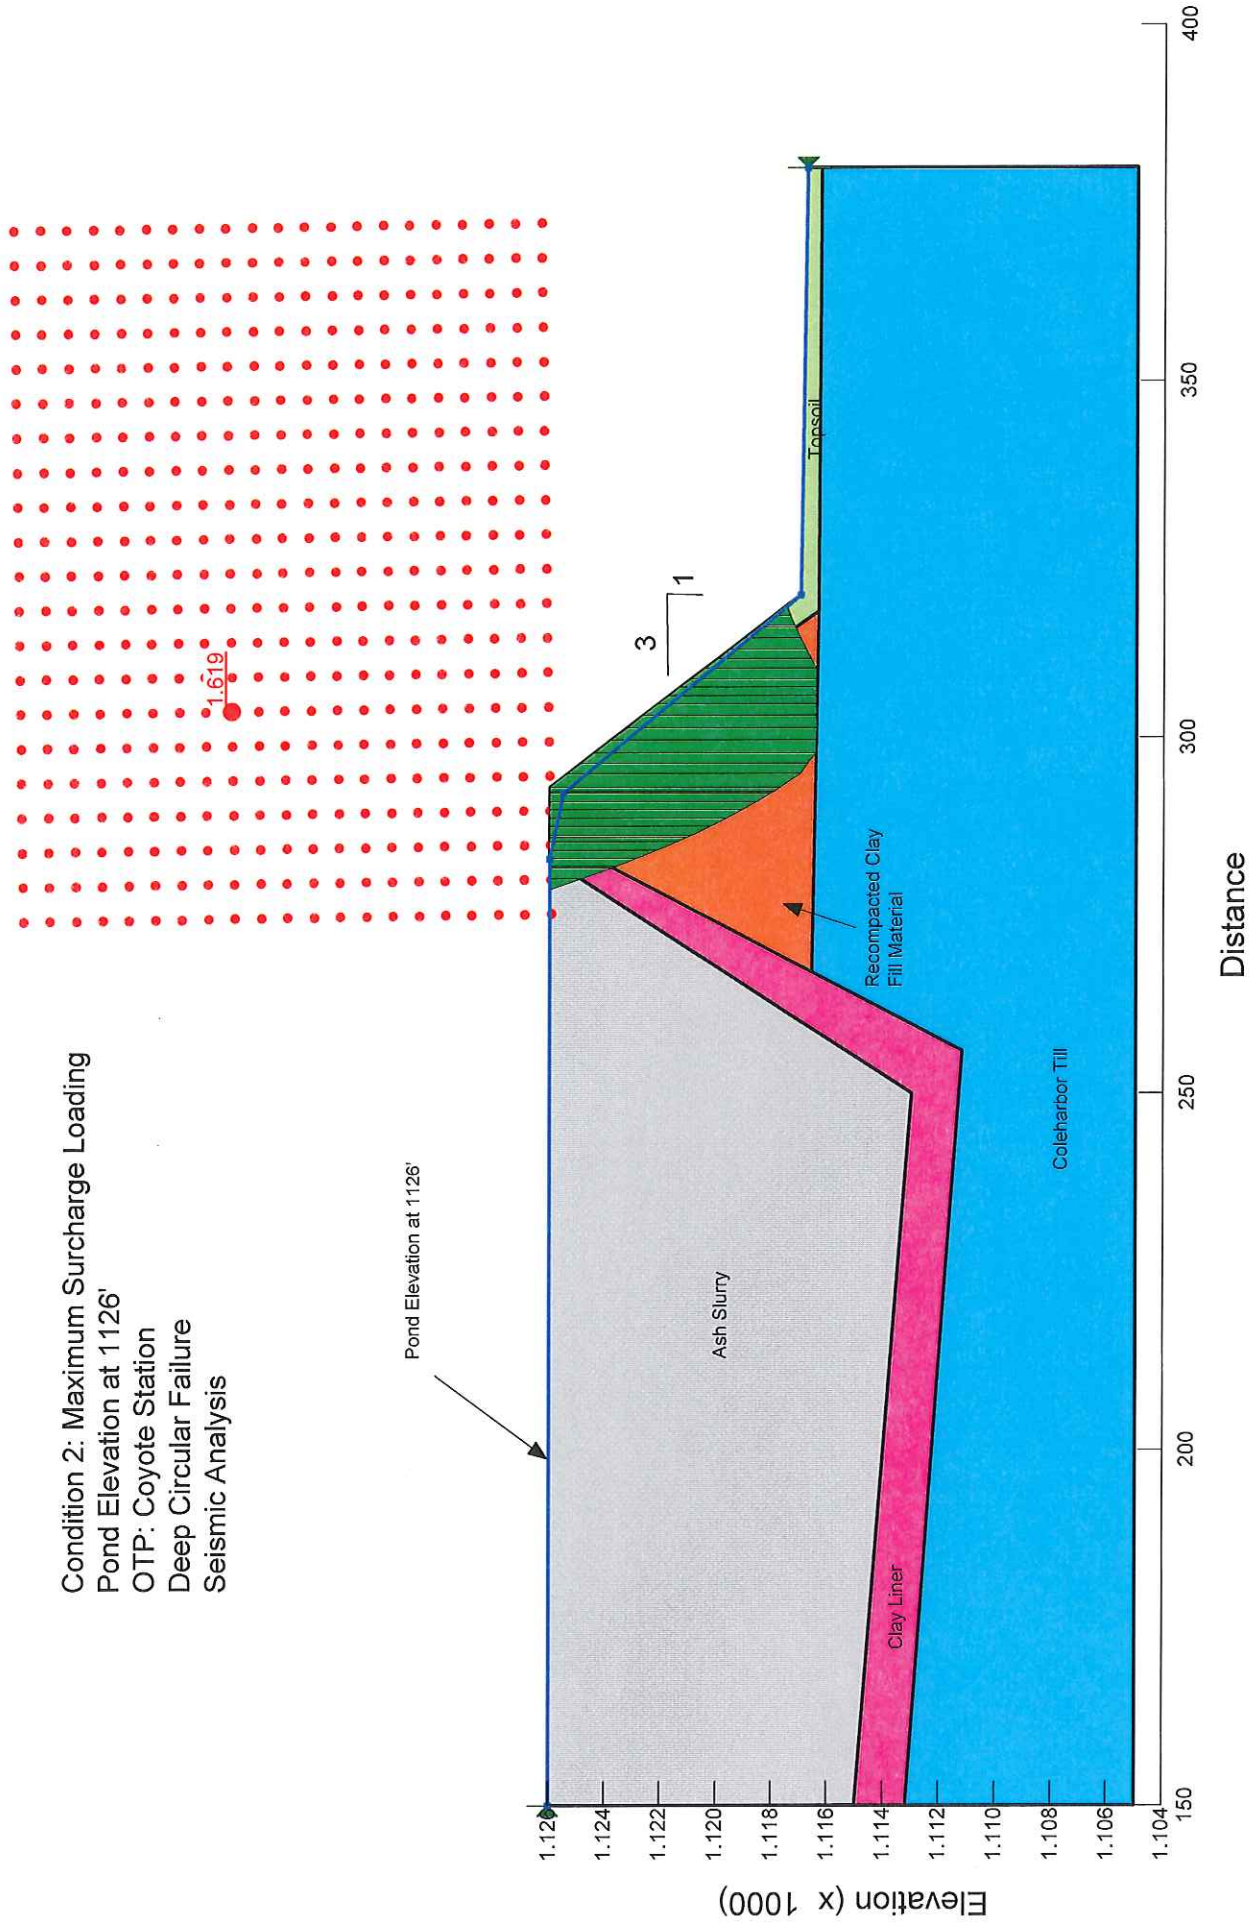
Condition 2: Maximum Surcharge Loading  
Pond Elevation at 1126'  
OTP: Coyote Station  
Deep Circular Failure  
Seismic Analysis

The results of the static and seismic analyses are summarized below in Table 2. The full graphical results can be found in the Attachments.

Facility Phase	Static FOS	Minimum Allowable FOS	Pseudo Seismic FOS	Minimum Allowable FOS	Analysis Method
Condition 1 Long Term, Maximum Storage Pool Loading	<b>2.14</b>	1.50	<b>1.67</b>	1.00	Deep-Circular Failure
Condition 2 Maximum Surcharge Loading	<b>2.11</b>	1.40	<b>1.62</b>	1.00	Deep-Circular Failure
